ALMA Memo # 408

REPORT GEO 99/37 (REV. A)

GEOTECHNICAL STUDY CHAJNANTOR SITE, II REGION NOBEYAMA RADIO OBSERVATORY NRO – NRAO

March 2000

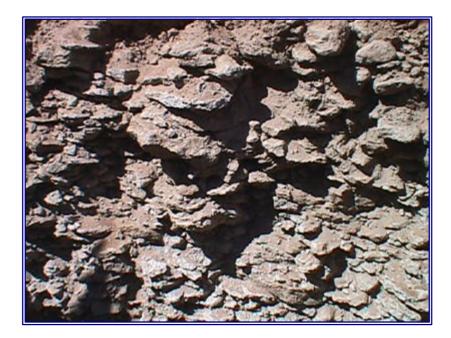
Figure 2. Photographs of Broken Rock in Trenches

A previous investigation performed by this Consultant by excavating trenches showed the nature and morphology of the broken rock horizon. Figure 2 shows two photographs of typical walls in the trenches. Figure 3 has two photographs of rock outcrop at the site also showing the "layering" morphology of the meteorized rock at the surface.

UPPER HORIZON BROKEN ROCK

LOWER HORIZON MASSIVE ROCK

BROKEN ROCK WEATHERED BY FROST-DEFROST CYCLES
